Manhole Inspection Summary

Manhole # S55A__028MH

Insp Date: **6/24/08 2:14 PM**

Location Address: **3500 pulaski hw**

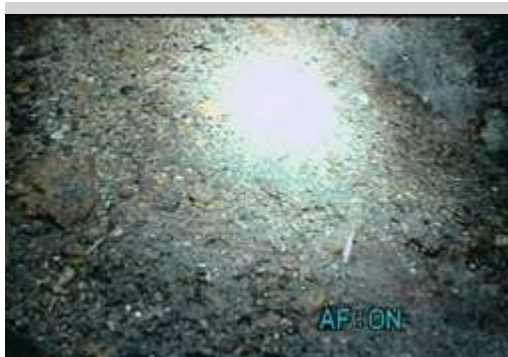
Defect 3

Condition: ☐ Sound ☐ Cracked ☐ Root Intrusion ☐ Deteriorated ☐ Leaks ☒ **Debris**

mound of bench debris

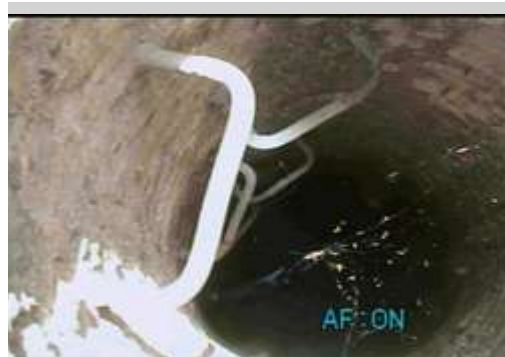
Defect 2

Steps Count: **8** Missing: **0** ☒ **Corroded**

steps

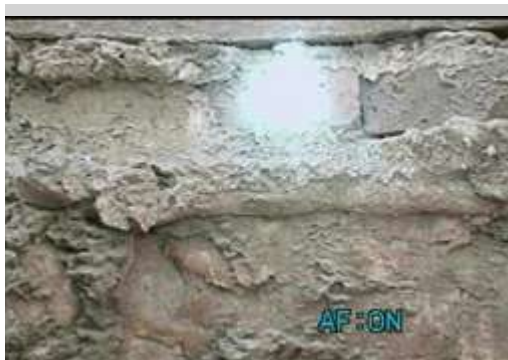
Defect 1

Condition: ☐ Sound ☐ Cracked ☐ Root Intrusion ☒ **Loose Brick** ☒ **Deteriorated**

chimney loose bricks,deteriorated,
frame adj

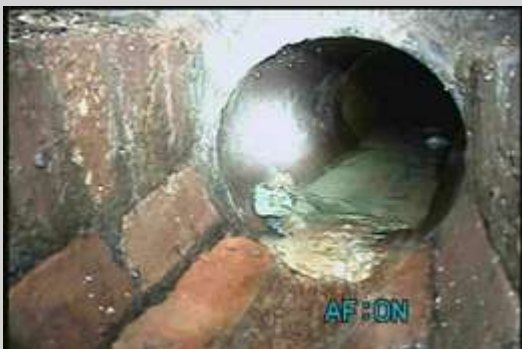
7 O'Clock Inflow

Deposits: ☐ None ☐ Mud ☐ Sludge ☒ **Debris** ☐ Grease

Silt Depth: 2 (in.) Deposits Extent: **Light**
